FAILURE'S IDENTIFICATION OF TURBOCHARGERS OF INTERNAL COMBUSTION ENGINES BY MEANS OF MULTI-FUNCTIONAL TEST STAND

In connection to that in article have been presented identification of common failures occur in turbochargers. Moreover, conception of multi-functional diagnostic test stand have been also presented. Such method will be an extremely useful tool for verifying the effectiveness of repairs, which will be important in terms of their subsequent use (confirmation, that the repair has been performed properly), environmental protection and in case of conflict between

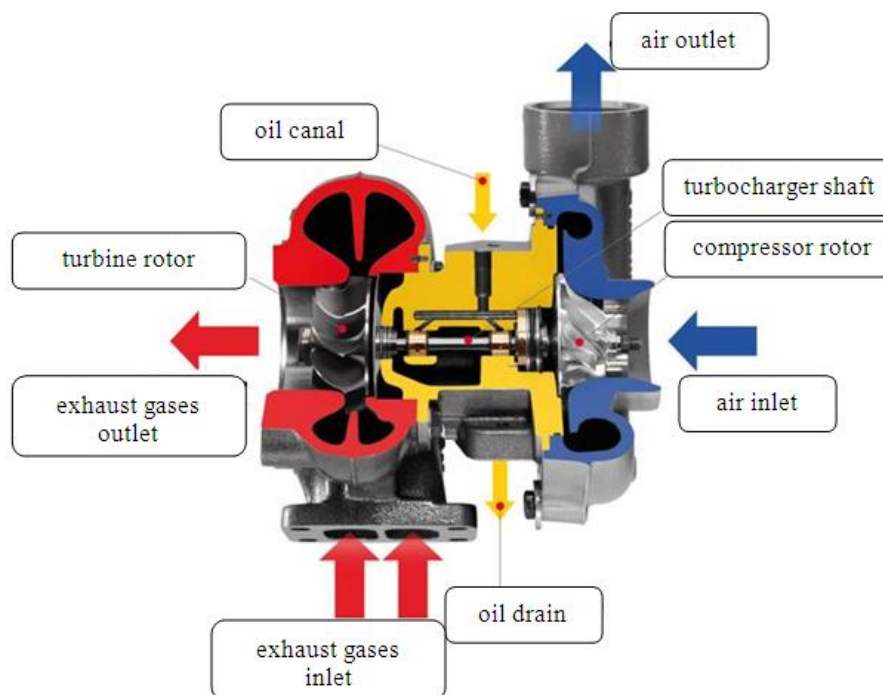
Supercharging the internal combustion engine is delivery of fresh charge of increased density into the cylinder, which enables supplying it with more fuel without altering the air-fuel ratio λ . The aim of the process is to maximize the unit power and efficiency of the engine but also to reduce unitary emission of toxic exhaust components. Turbocharging belongs to the category of compressor supercharging with a flow compressor. The main component is a turbocharger – fluid-flow machine in which the turbine and compressor rotors are mounted on a common shaft (fig. 1).

Fig. 1. Cross section and principle of operation of turbochargers

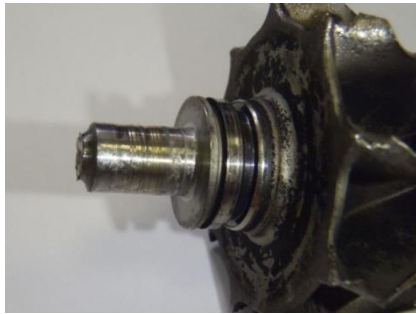
Since a turbocharger is lubricated with oil from the engine, it happens that the oil is of insufficient quality. Because of the hard operating conditions in the engine its physical characteristics (density, viscosity) and other parameters (foaming resistance, for example) deter [1]. Moreover, solid macroparticles such as products of abrasive wear of engine's components, corrosive wear etc. can be included in the oil, which microcut, scrape and furrow outer layers of friction nodes. The deterioration of the quality parameters of the oil during the use of the vehicle is a normal phenomenon. Causes of damage to turbochargers done by oil of poor quality should be sought for in engine oil primarily of poor quality – not complying with the manufacturer's recommendations. Also the oil filter may be inadequate, being of incorrect parameters or choked by soil. The most common cause in this type of failure is however a result of a lack of periodical or distance-determined oil change according to the manufacturer's recommendation. Turbocharger damage caused by oil of poor quality results in, among others, deterioration of the operating conditions of the axial and radial bearings, as a result of the diminishing of the diameter of oil holes. It can cause local overheating of the components and growth of the contact temperature, which can result in rapid damage of the turbocharger revealed by, among others, deep scrapes on the rotor's shaft necks (fig. 2) and bearing surfaces (fig. 3), alteration of parameters of the outer

Fig. 2. View of broken rotor's shaft necks with deep scrapes

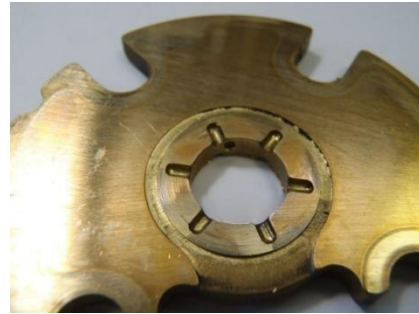
Fig. 3. View of scraped surface of bearing

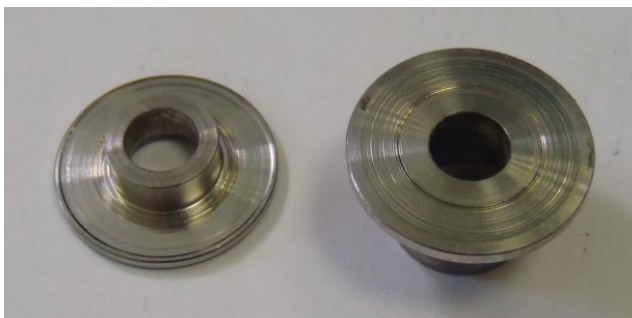
contact layers (fig. 4), decalibration of the holes for bearings in the inner housing, or the ring seals becoming stuck in their grooves (fig. 5).

Fig. 4. View of changes in parameters of the outer contact layers

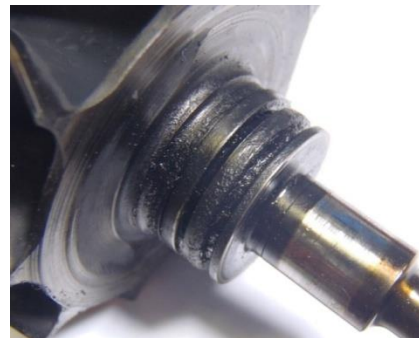
Fig. 5. View of rotor's shaft with ring seals becoming stuck in their grooves

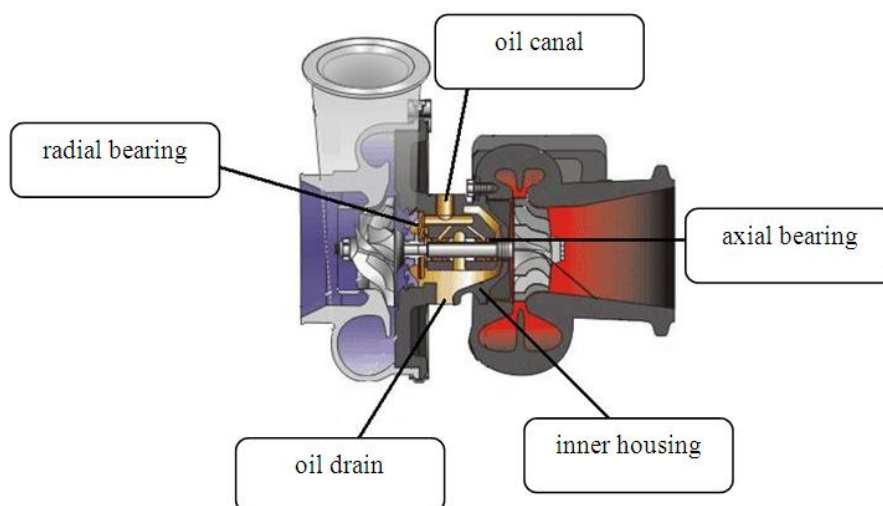
Consequences of improper oil parameters have been described above. Another failure type, also related to oil, is one caused by the change in its operating parameters, for instance pressure drop or a momentary lack of oil. Mechanical parameters are thus of importance – oil should be delivered to the turbocharger in adequate amount and at proper pressure. It is also important that the oil outflows sufficiently quickly out of the friction zone and the inner housing (fig. 6).

Fig. 6. Cross section of turbocharger with visible inner housing and oil canal

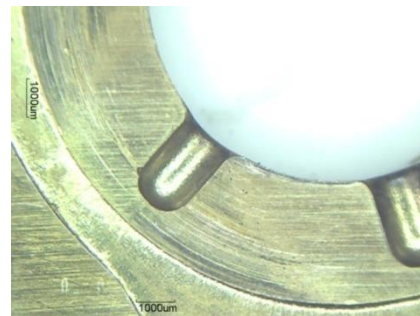
- damage of the outer layers of bearings and rotors' shaft neck (fig. 7),
- alteration of physical properties of the material the shaft and bearings are made of (fig. 8),
- the bearing sleeves becoming stuck in the inner housing holes (fig. 9),
- thermolysis of the oil components (coking) – leading to carbon depositing in oil holes of the inner housing, causing them to choke (fig. 10).

Fig. 8. View of alteration of bearing material

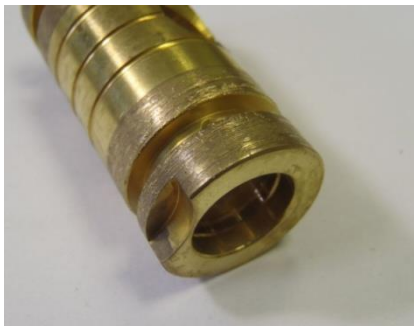
Fig. 9. View of faded bearing (dry friction)

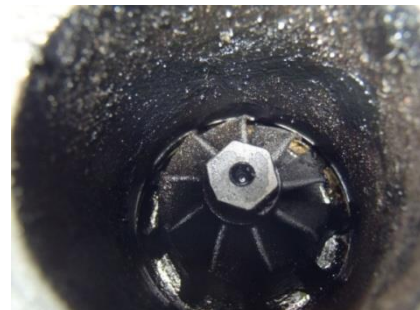
Fig. 10. View of turbine rotor with carbon depositing

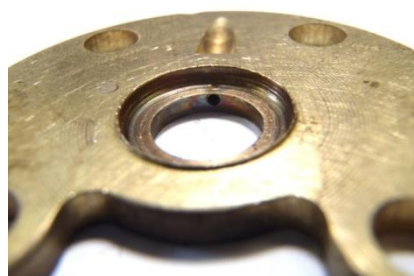
Another type of failure identified is that caused by overheating. It has in principle two causes: too high exhaust temperature and sudden stoppage of the engine preceded by driving with considerable load and rotational speed [3]. Hot exhaust strongly heats the turbocharger's components – particularly cast iron housing of the turbine and the inner housing (fig. 11).

Fig. 11. View of bearing with hot tracks

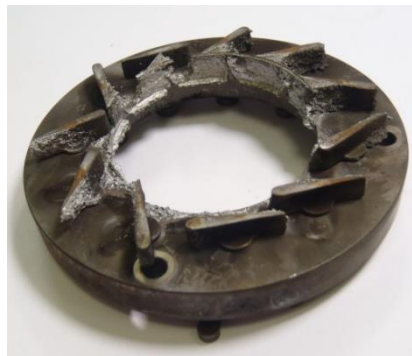
The last common type of failure is that caused by foreign matter. This type of failure is a result of foreign matter working its way to the in- or outflow system (fig. 12).

Fig. 12. View of exhaust steering wheel with contaminations on surface

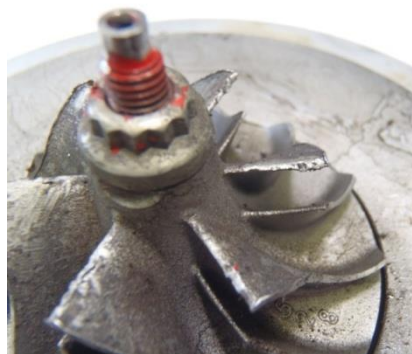
The failure is of an erosion type and depends on the size of the body reaching the rotors blades. Even the smallest body carried with the exhaust or air flow reaching the rotor strongly impacts the blades as a result of the high energy of the gas flow (fig. 13).

Fig. 13. View of compression rotor with tracks caused by small body

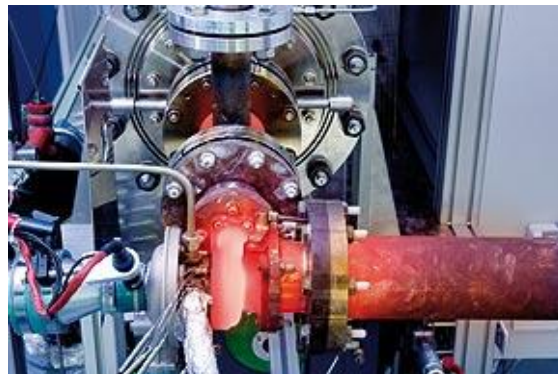
On the basis of identification of described failures a conception of device which allows for turbochargers diagnostics have been elaborated. For the research of wear and destruction processes of turbochargers, and so their diagnostics, a test stand is needed which will enable to simulate the component's operating conditions, i.e. accelerating the turbocharger's rotor to a given speed, ensuring constant lubricant parameters and setting the desired parameters of the charging air. The companies specializing in design and examination of the manufactured turbochargers use devices enabling them to create flow characteristics of the turbine and compressor and which can be also adapted for research of destructive processes. Such devices use either compressed air from a tank, or hot combustion gases from an exhaust generator as power feed. The basic disadvantage of such solutions is the big volume of the air tank, being a result of a difference in energy states of air and exhaust. The exhaust which in real conditions propels the turbocharger's rotor has considerable energy, which derives mostly from its speed (around 500 m/s) and temperature (up to 1000 °C). Moreover, the exhaust stream generated by the engine amounts to 0,1 m³/min – 50 m³/min, depending on the engine size and rotational speed. In practice such solutions are often abandoned and the rotor is driven by exhaust in the so-called hot gas test [4] (fig. 14).

Fig. 14. View of devices which allows for turbochargers testing

The devices used for this procedure are fitted with an exhaust generator of adjustable parameters: rate of delivery, temperature and pressure. Similarly as with the air tank solution, also this device enables to determine the turbocharger's characteristics. It is also possible to test the turbine under extremely hard conditions and conduct fatigue research as well as continuous monitoring of the operating conditions.

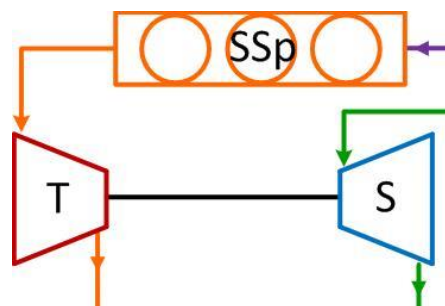
Based on the presented information, in the first phase a solution has been chosen, in which the turbocharger shall be propelled by an exhaust stream (fig. 15). The research version of the stand uses a normally aspirated combustion engine being the exhaust generator. Spark-ignition engine coupled with a water brake which receives the power, has been used for the purpose – such a device is in possession of engine test house of the Combustion Engines Laboratory of the Poznań University of Technology (fig. 16).

Fig. 15. Schematic diagram of turbochargers test stand

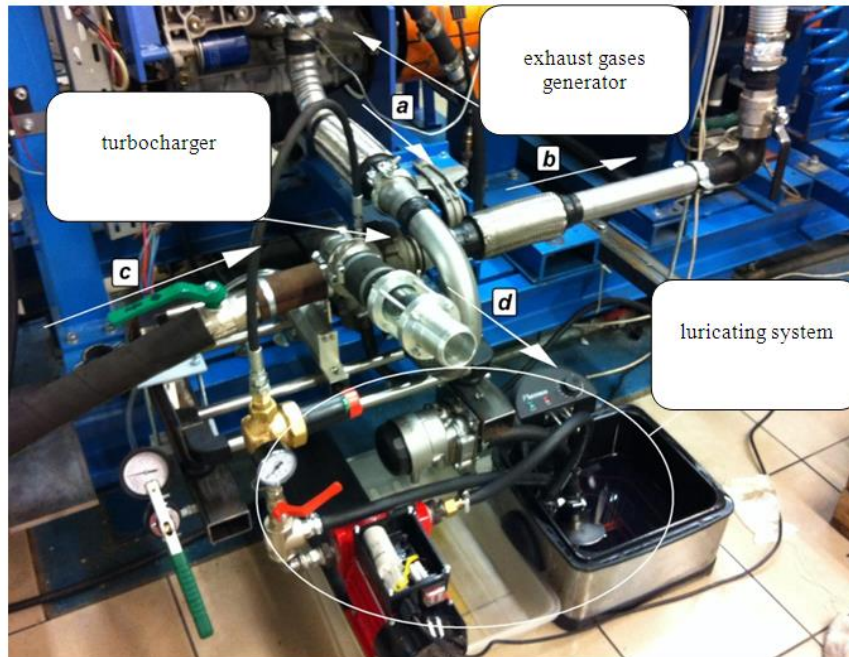
Fig. 16. View of turbochargers test stand

The engine is fitted with a complete apparatus for constant operation and power and torque adjustment, thanks to which it is possible to generate a controlled exhaust stream of a given parameter, i.e. temperature or pressure. Air and fuel are delivered to the engine's combustion chamber, where the combustion of the air-fuel mixture takes place.
